CHECK IT OUT

TAKING A 25-YEAR-OLD BOAT TO THE EXPRESS LANE — WITH 12 ITEMS OR LESS

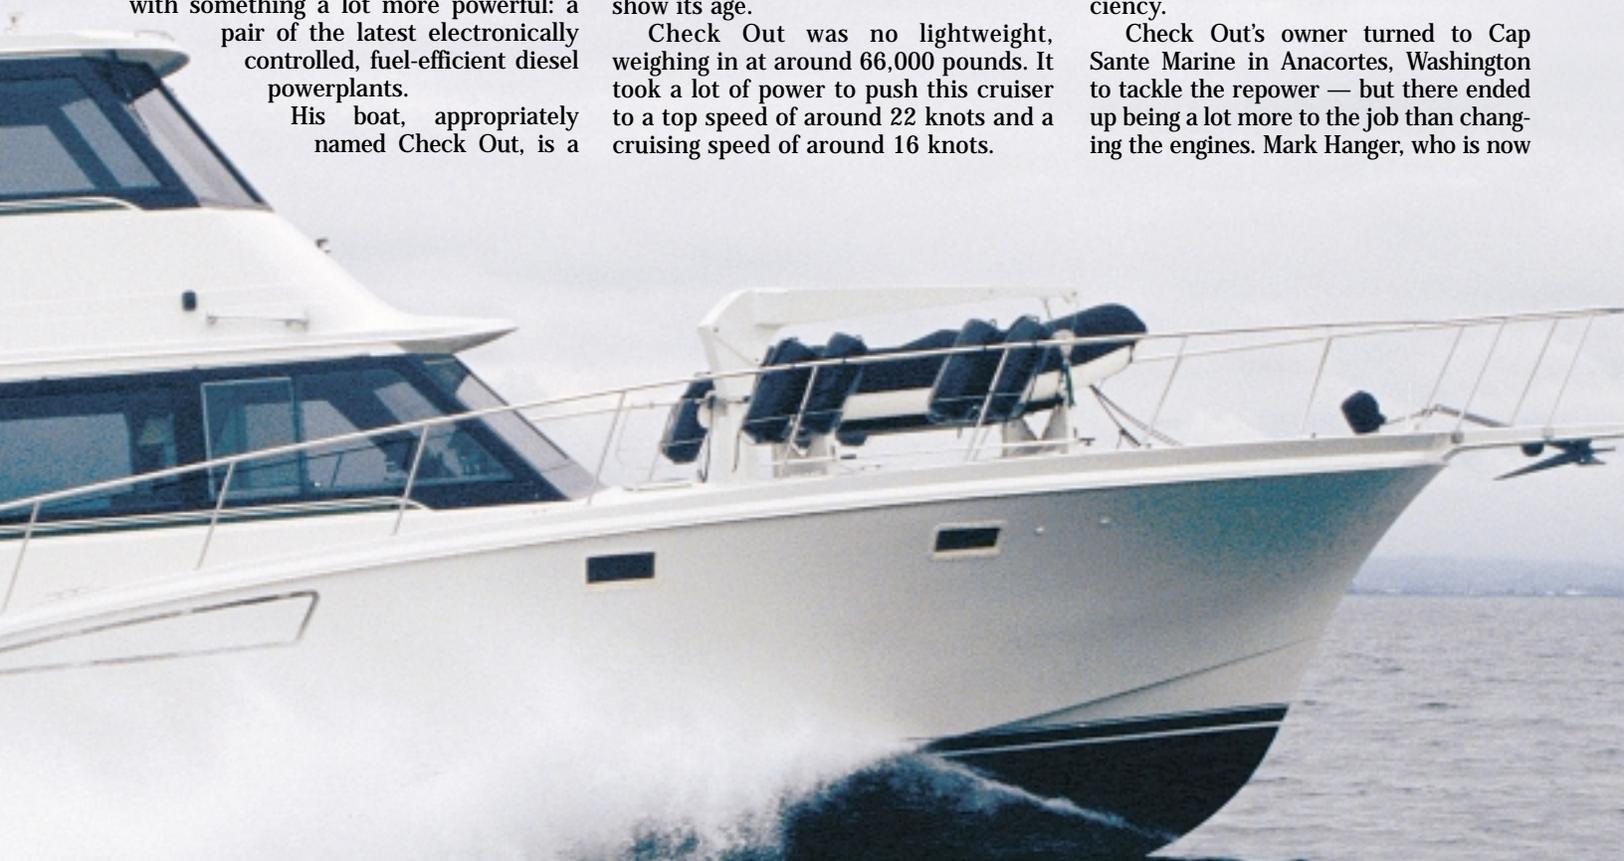
NEW ARRIVALS — Big changes aboard the 1977 Uniflite 54 Check Out included removal of old controls and gauges to make room for new Mathers electronic controls and electronic instrumentation (top left).

The old dash gauges were thrown out and replaced with cutting-edge Cummins digital electronic engine instrumentation. These new digital displays monitor every engine function and offer complete performance data at a glance.

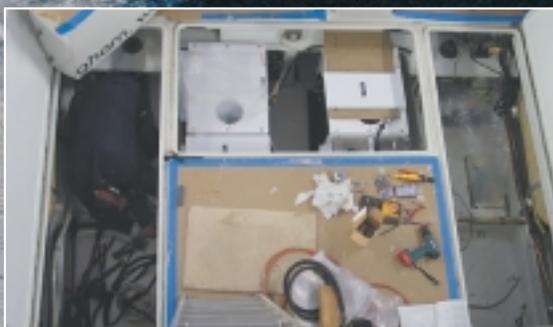
New Cummins QSM 11 electronically controlled diesels (top right) were installed, along with new 9 kw Onan EQD electronically controlled gensets (bottom right).

Once the new engine room was ready, a pair of brand-new 635 hp Cummins QSM11 diesel engines was installed — with the same giant-size crane and careful crew, inching the powerplants into place.

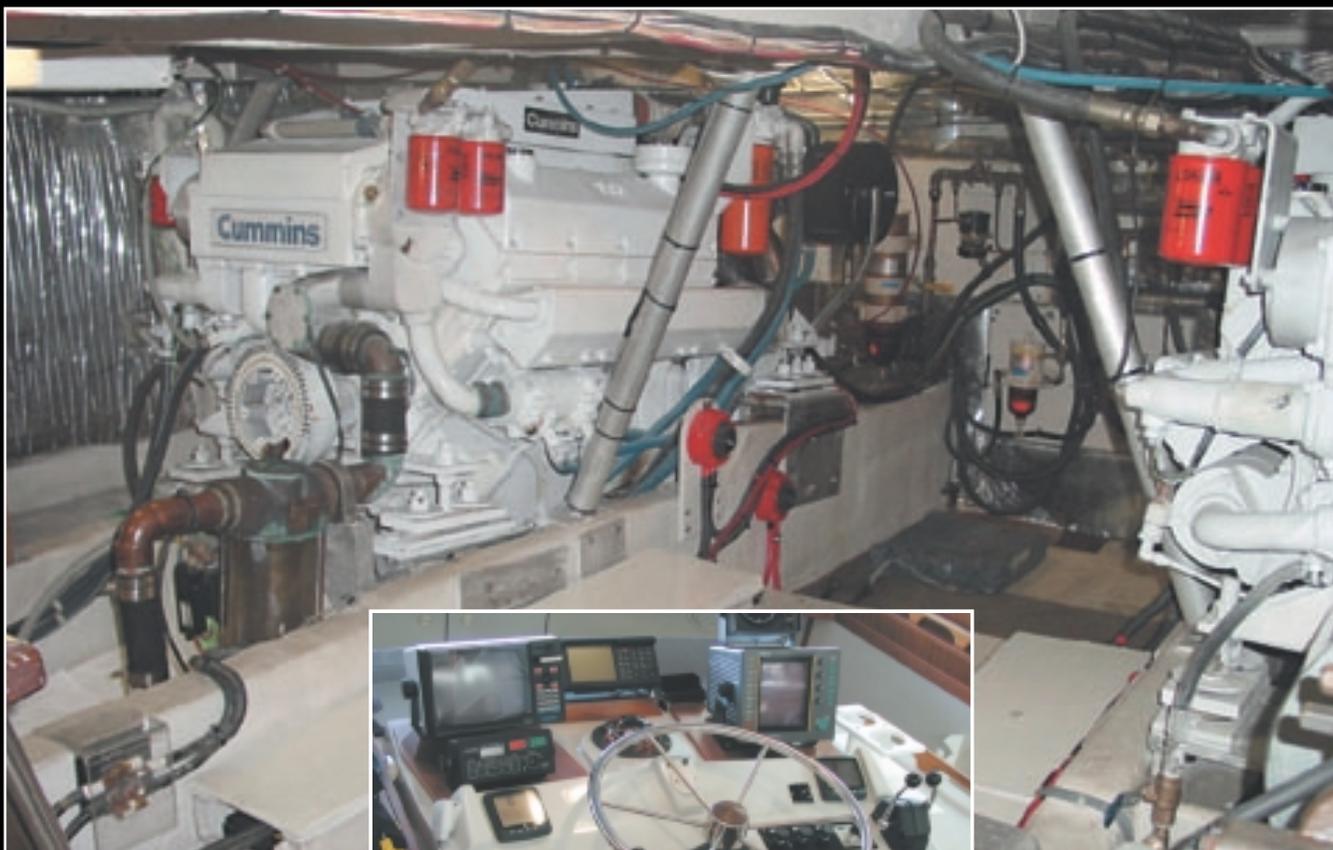
AMAZING TRANSFORMATION — Check Out’s original 420 hp Cummins BT 903 diesels (top) were more than 20 years old. The new electronically controlled engines that replaced them — 635 hp Cummins QSM 11 diesels — offer better fuel efficiency and performance. The boat now cruises 4 to 6 knots faster, and electronic helm instrumentation (center) allows the skipper to track all key performance data.

The entire job was finished by spring 2002. With all the changes, *Check Out*’s owner experienced a dramatic drop in fuel consumption and a significant improvement in performance. The boat now cruises at 18 to 20 knots (instead of 16) and can achieve a top speed of just over 26 knots (instead of 22).

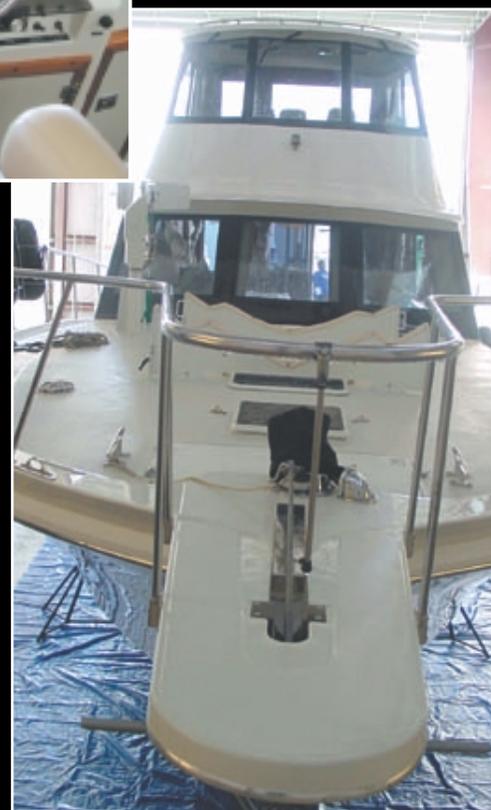
POWER UP — Before two new Cummins diesels were hoisted into the boat, lowered through the saloon floor and mounted in the engine room, Cap Sante Marine technician Chris May (left) installed new instrumentation.

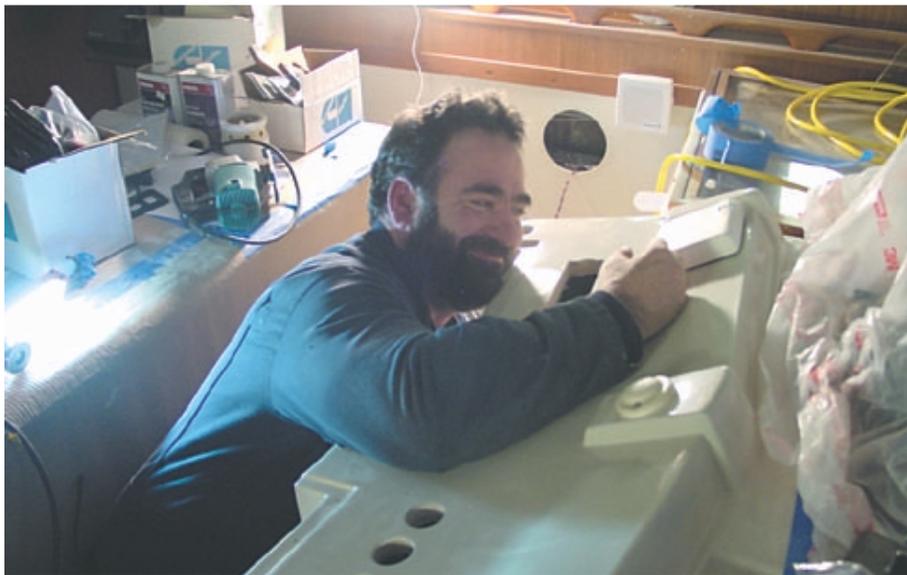
UNDERCOVER WORK — After *Check Out* was hauled out, Cap Sante Marine performed most of their repower project inside a covered facility at the South Yard.

Check Out was hauled out by the Travelift, and moved into a covered facility. There it was supported on numerous stands, and every piece of furniture, drapery, carpeting and woodwork in the interior was covered, to protect it against dust or potential impact abrasions during the construction process. After all, the old engines would have to come out — and the new engines would have to go in — through the saloon.
